A study of cleaning characteristics for EUV mask blanks

Kyoko Sakai, Yo Sakata,
Tadashi Matsuo, Keishi Tanaka

Product Innovation Laboratory,
TOPPAN PRINTING CO., LTD.

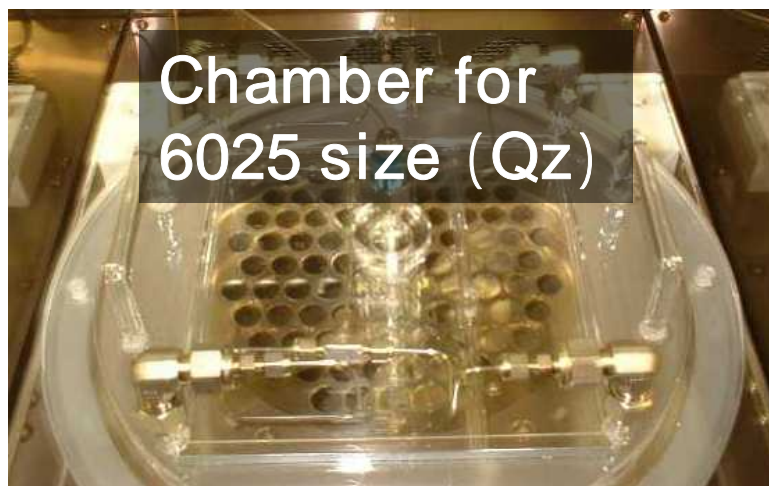
Experimental A - Organic analysis tool

TD (Thermal desorption) - GC/MS

He gas flow control

TD condition

30
300 (15 /min)
300 (42min hold)

GC condition

40 (5min)
280 (10 /min)
280 (21min hold)
